Manhole Inspection Summary

Manhole # S45II_056MH

Insp Date: **4/29/08 2:57 PM**

Location Address: **Oliver St**

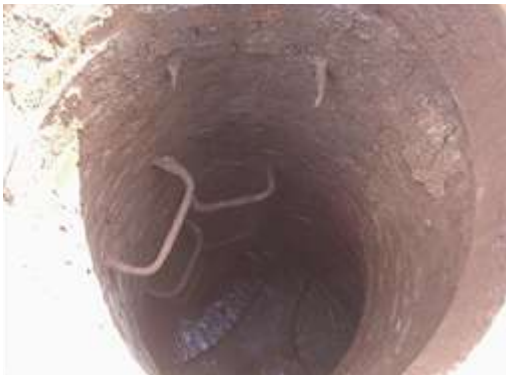
Defect 2

Condition: ☐ Sound ☒ **Cracked** ☐ Leaks

frame leaks

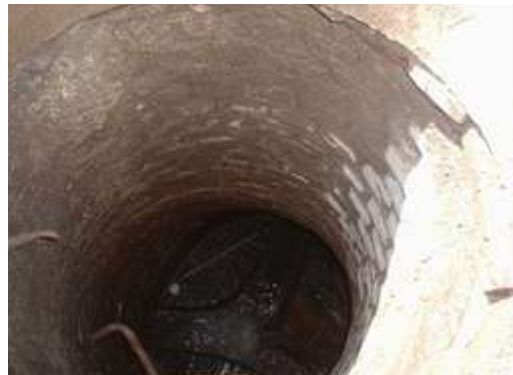
Defect 1

Infiltration: ☐ None ☐ Joint ☐ Cracks ☐ Mortar ☐ Roots ☒ **Wall**

infiltration

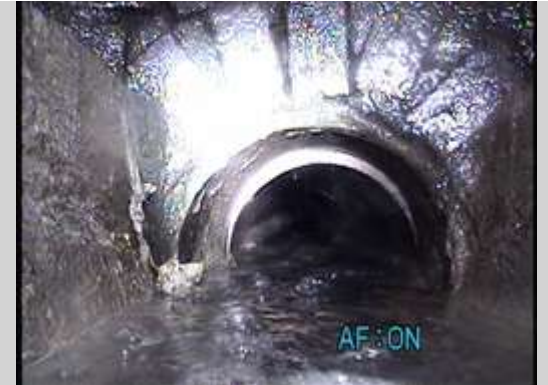
12 O'Clock Outflow

8 in. Circular Gravity Sewer
Pipe Out @ 12 O'Clock

Pipe Height: **8.4** (in.) Rod and Bar (Angled)
Pipe Material: **Clay** ☐ Pipe Lined
Invert Depth: **13.50** (ft.) Flow Characteristics: **Fast**
Deposits: ☒ None ☐ Mud ☐ Sludge ☐ Debris ☐ Grease
Silt Depth: (in.) Deposits Extent:
Infiltration: **None** Pipe Seal Cond: **Sound**

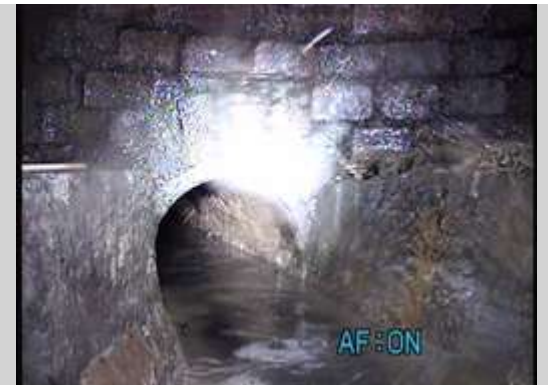
3 O'Clock Inflow

8 in. Circular Gravity Sewer
Pipe In @ 3 O'Clock

Pipe Height: **8.4** (in.) Rod and Bar (Angled)
Pipe Material: **Clay** ☐ Pipe Lined
Invert Depth: **13.60** (ft.) Flow Characteristics: **Fast**
Deposits: ☒ None ☐ Mud ☐ Sludge ☐ Debris ☐ Grease
Silt Depth: (in.) Deposits Extent:
Infiltration: **None** Pipe Seal Cond: **Sound**

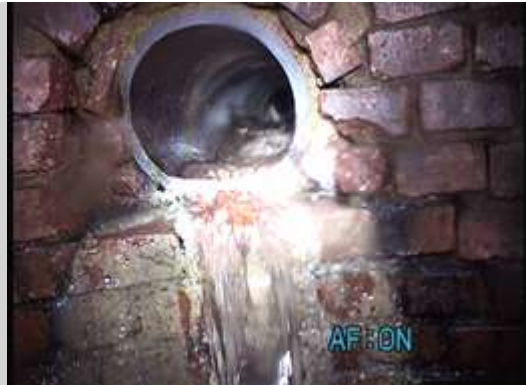
8 O'Clock Inflow

Pipe In @ 8 O'Clock

Pipe Height: **8.4** (in.) Rod and Bar (Angled)

Infiltration: **None** Pipe Seal Cond: **Sound**

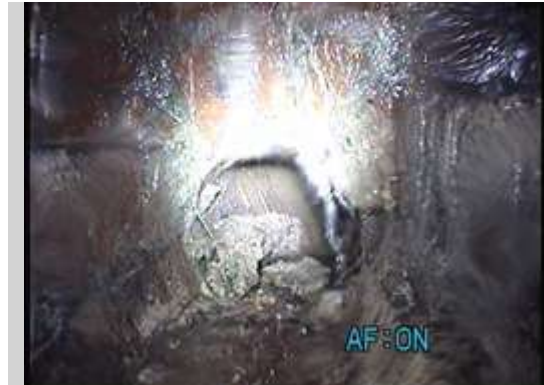
Drop In @ 8 O'Clock

Drop: **Inside**

Drop Condition: **Open**
